Earthquakes and Tailings Dams

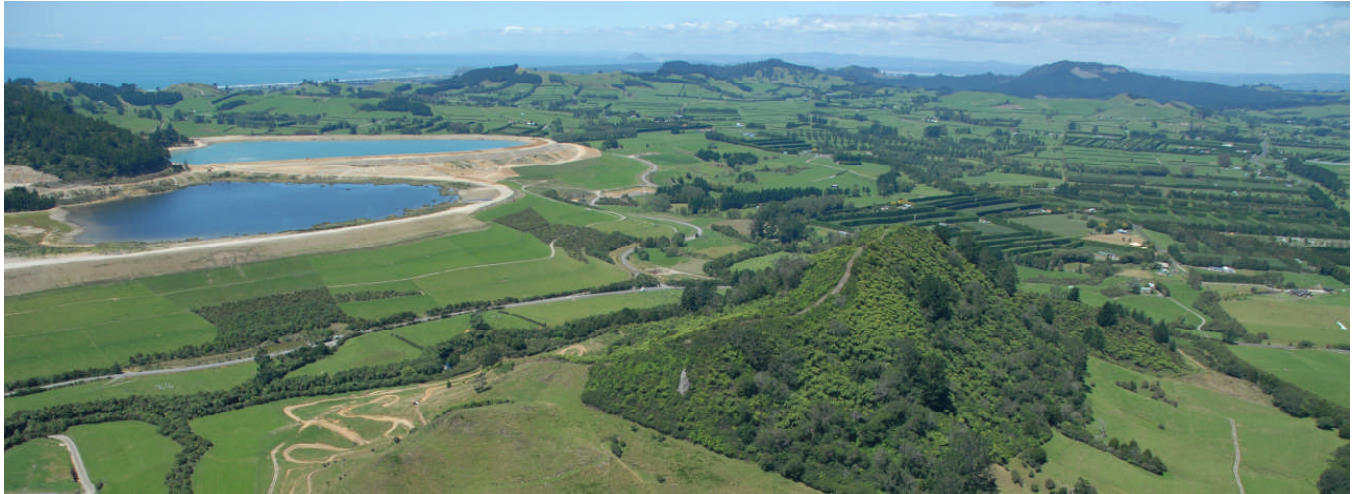
Above: The tailings dams at Waihi. Storage 2 is to the left, Storage 1A is behind it. Photo taken February 2011

- The embankment slopes are gentler than necessary due to the availability of large quantities of rock from the Martha Mine open pit
- The foundations are solid, based on bedrock present at shallow depth
- The tailings themselves consolidate with time to be essentially soil that is not prone to liquefaction, unlike many other types of tailings.

Within the embankments storage capacity is provided for a 1,200mm rain storm (the Probable Maximum Precipitation) plus an additional 1.0 metre minimum freeboard. The downstream shoulder of the embankment is considerably flatter than would normally be the case for water retaining embankments. The slope of Storage 1A is typically 3.2:1.

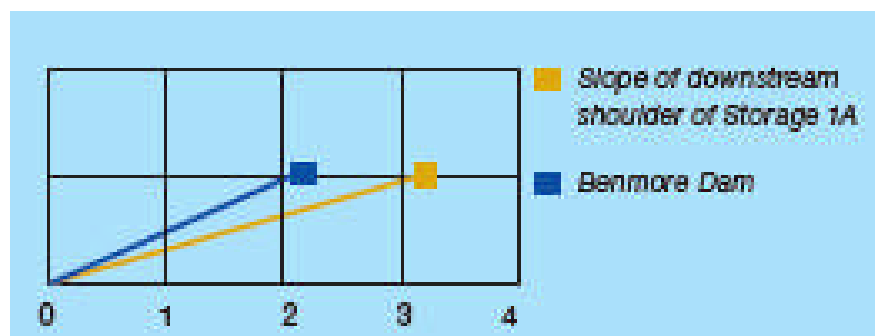
This compares to about 2.2:1 for the Benmore Dam, the highest hydro dam in New Zealand.
